Quantification of Cracked Areas in IGBT Modules

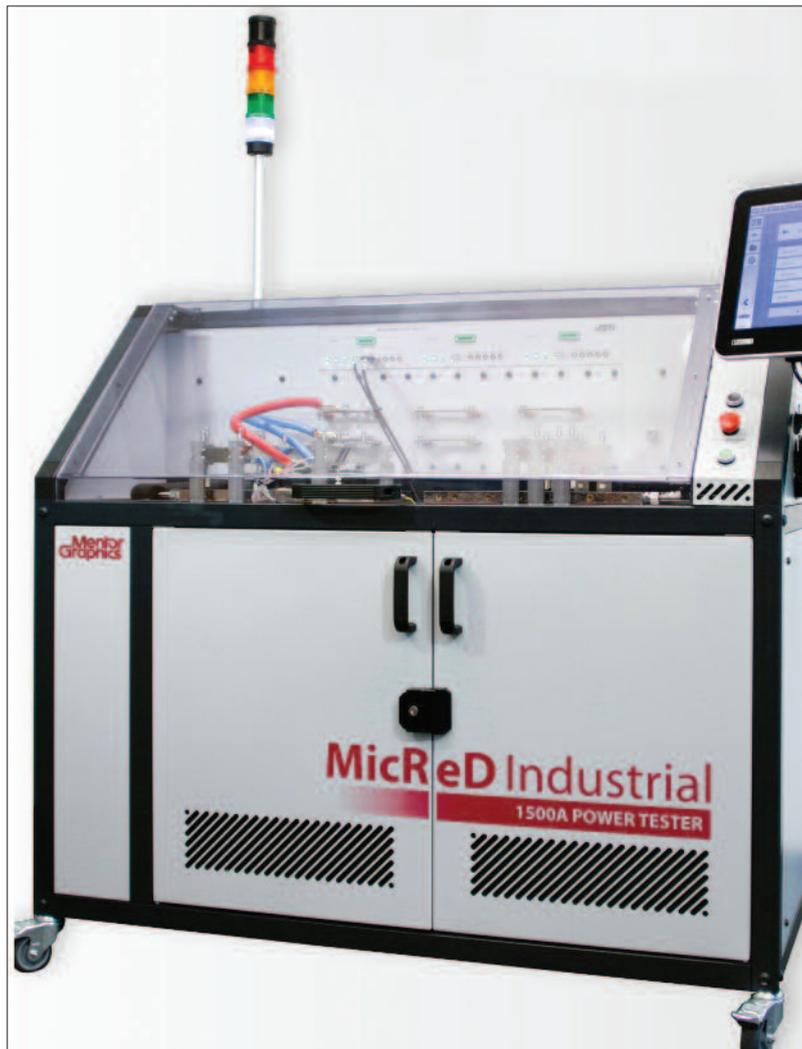
Figure 1: High-power multi-chip power modules can be characterized using MicRed Power Tester® 1500A

Under these conditions, the wire-bond lift-off mechanism is not the dominant mechanism and the substrate mount-down solder degrades before any wire-bond lift-off is observed. The power cycling was paused regularly every 1000 cycles, at which time a thermal impedance measurement was made of the module in situ by the 1500A Power Tester (Figure 1) and this resulted in a total of 17 thermal impedance measurements during the test.

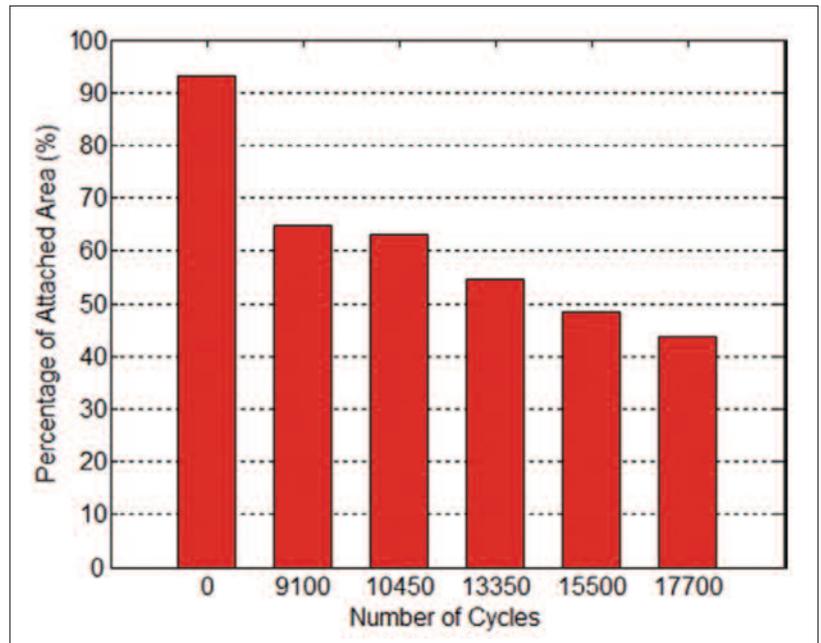
Figure 4: Estimated attached area of solder layer during the cycling test from SAM images

metallurgical cross-sectioning was necessary (Figure 3). Figure 4 shows the estimated attached area of the solder layer at different cycle numbers during the cycling test. As the number of cycles increases, cracking propagates through the solder causing the attached area to be reduced gradually until it reaches 43 % attached area after 17,700 cycles.

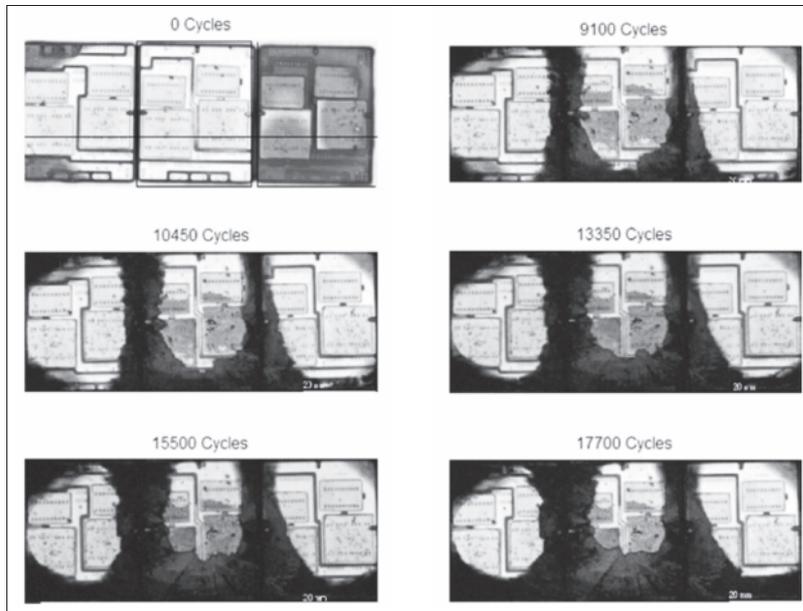
Figure 2: Scanning Acoustic Microscopy (SAM) images at different cycles during the power cycling test

Defects at any of the internal layers cause discontinuity in the structure and block the ultrasonic signal preventing it from penetrating through the layers beneath the defected areas. Thus, defects in the substrate solder result in a black shadow appearing in the C scan images taken from the chip level (Figure 2). In this

way, the C scan images were used to obtain distinct boundaries between the attached and discontinuous areas. However, the exact location of the defects within the structure can be unclear from SAM images, and therefore, correlative

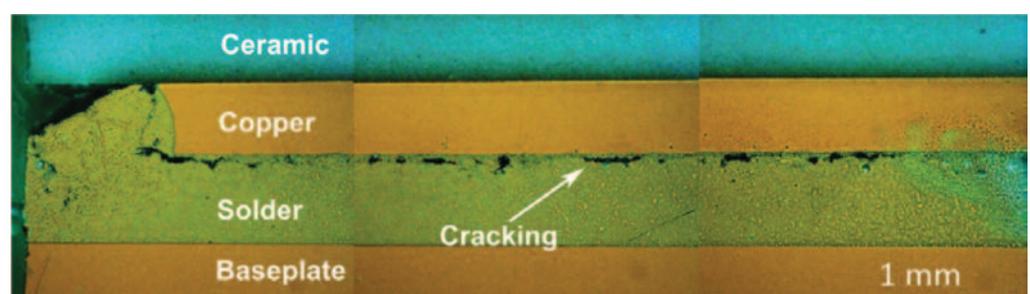
RIGHT Figure 3:
Image of metallurgical cross-section showing the cracking resulting from power cycling at the substrate-baseplate interface

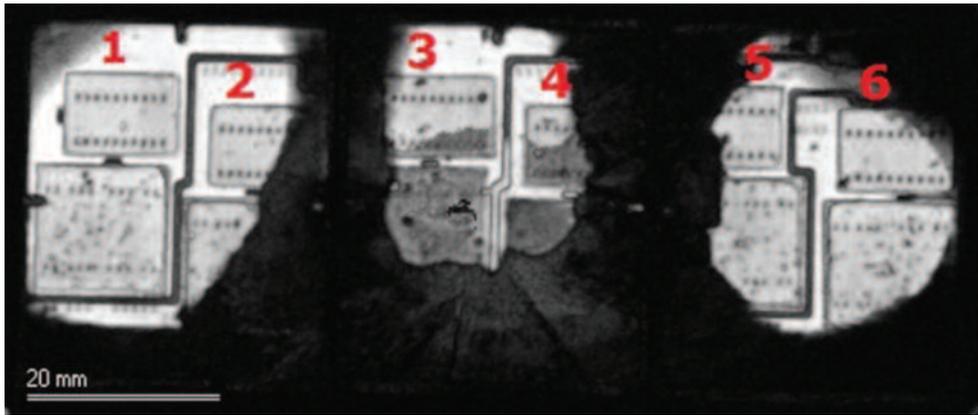
Figure 5: SAM image of the cycled module at 17,700 cycles shows different levels of delamination under the 6 IGBT devices

was estimated from the SAM image at 17,700 cycles shown in Figure 5.

The different thermal layers can be easily identified related to Device 1 and Device 6 as they are the least affected by solder fatigue. Features of the different layers in the structure start to disappear as the level of local delamination increases in the other devices. Device 4 is the worst affected by cracking. Hence the thermal resistance R_{thjc} may be directly compared with the percentage of attached area below the individual IGBTs.
